DAVIS & HOME INSPECTION AND RENOVATION COMPANY

ASHI Certified Uniform Residential Inspection Report  
**HOME INSPECTION REPORT PREPARED FOR:**

**JACK & LORI PETTY**  
OF  
**107 RAINBERRY DRIVE**  
**MOORESVILLE, NC**

DATE OF INSPECTION Thursday, February 04, 2010 @ 3:00 PM

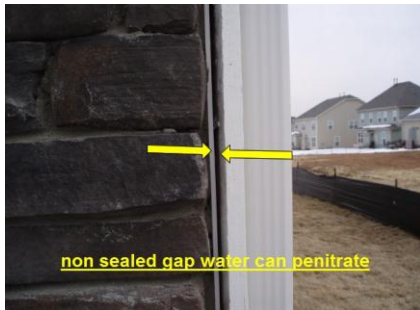
1. GAPS BETWEEN CONCRETE STONE AND TRIM VERTICAL BOARDS ON RIGHT SIDE OF GARAGE DOOR WHICH CAN ALLOW WATER TO INFILTRATE. SUGGEST FURTHER INVESTIGATION BY A LICENSED CONTRACTOR TO DETERMINE EXTENT OF REPAIRS.

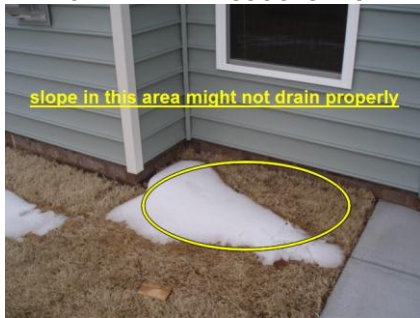
2. SLOPE OF YARD AT REAR CENTER NEXT TO PATIO, HOME AND FIREPLACE DOES NOT APPEAR TO BE PROPER. THE SLOPE APPEARS TO BE AROUND 1" FOR EVERY 1' AWAY FROM HOME OUT TO 5' TO 6'. SUGGEST FURTHER INVESTIGATION BY A LICENSED CONTRACTOR TO DETERMINE IF ANY REPAIRS TO SLOPE IS NEEDED.

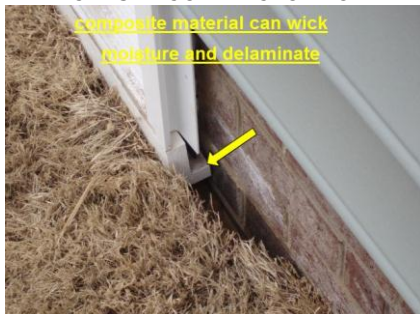
3. WOOD / COMPOSITE UNDER RIGHT SIDE GARAGE DOOR THRESHOLD IS IN CONTACT WITH THE SOD AND GROUND AND CAN WICK WATER AND DELAMINATE. SUGGEST FURTHER INVESTIGATION BY A LICENSED CONTRACTOR.

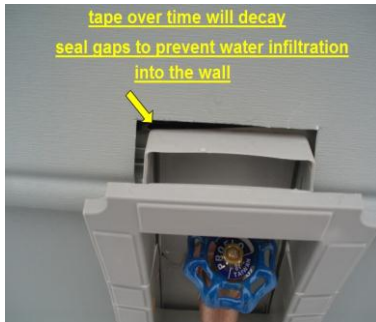
4. FLANGE ON TOP OF LEFT HOSE BIB BOX IS MISSING / CUT OFF WHICH CAN ALLOW WATER TO INFILTRATE BEHIND BOX, REPAIRS NEEDED.

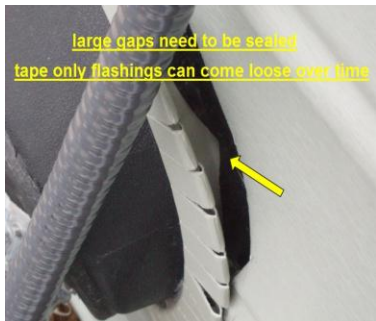
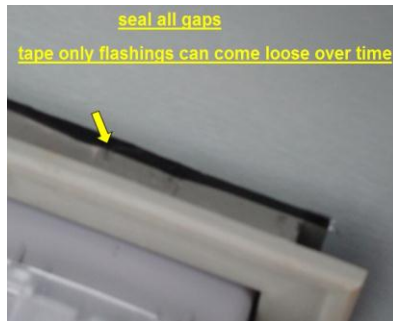
5. UNABLE TO SEE THE FLASHINGS OVER AND AROUND THE FREON LINES WHERE THEY ENTER THE HOME. IT LOOKS LIKE A RUBBER WET PIPE BIB WAS USED. ALSO, UNABLE TO SEE FLASHINGS OVER AND AROUND REAR RIGHT POWER OUTLET BOX AS LARGE GAPS ARE PRESENT AND IF THIS AREA IS NOT SEALED CORRECTLY IT CAN LEAK WATER INTO THE WALL. PLASTIC WRAP WAS ONLY OBSERVED. SUGGEST FURTHER INVESTIGATION BY A LICENSED CONTRACTOR.

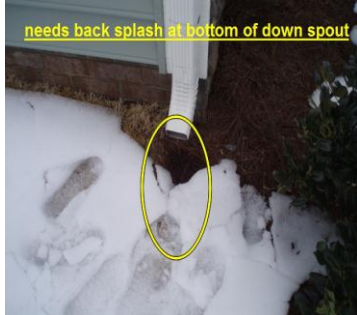
GUTTERS AND DOWNSPOUTS: STATUS KEY:[ 2 ]:  Appears serviceable, EXCEPT FOR MISSING BACK SPLASHES

needs back splash at bottom of down spout

1. DOWN SPOUTS ARE MISSING BACK SPLASHES AT BOTTOMS TO DIVERT WATER AWAY FROM FOUNDATION AND TO PREVENT EROSION OF THE GROUND. SUGGEST ADDING.

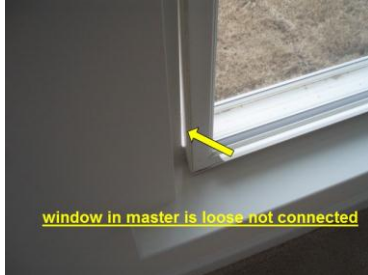
2. RIGHT SIDE REAR WINDOW IN MASTER BEDROOM IS NOT INSTALLED CORRECTLY. THE WINDOW WILL NOT STAY IN THE TRACK OR OPEN, REPAIRS NEEDED.
3. SQUEAKING SUB FLOOR ON UPSTAIRS LANDING OUTSIDE OF LEFT SIDE BEDROOM DOOR. SUGGEST FURTHER INVESTIGATION BY A LICENSED CONTRACTOR TO DETERMINE EXTENT OF REPAIRS.

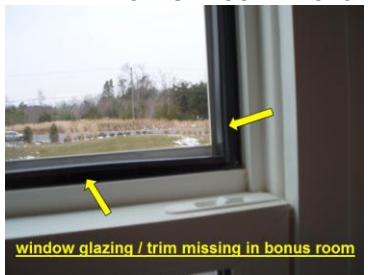
4. DAMAGED / MISSING GLAZING / TRIM ON FRONT CENTER WINDOW IN BONUS ROOM, REPAIRS NEEDED.
